**Five-Year Review Report #1
Hanscom Air Force Base Superfund Site
Middlesex County, Massachusetts**

**Prepared by:
Robert Lim
U.S. Environmental Protection Agency - Region 1
JFK Federal Building (HBT)
Boston, MA 02203**

September 1997

FIELD TRIP REPORT HANSCOM AIR FORCE BASE

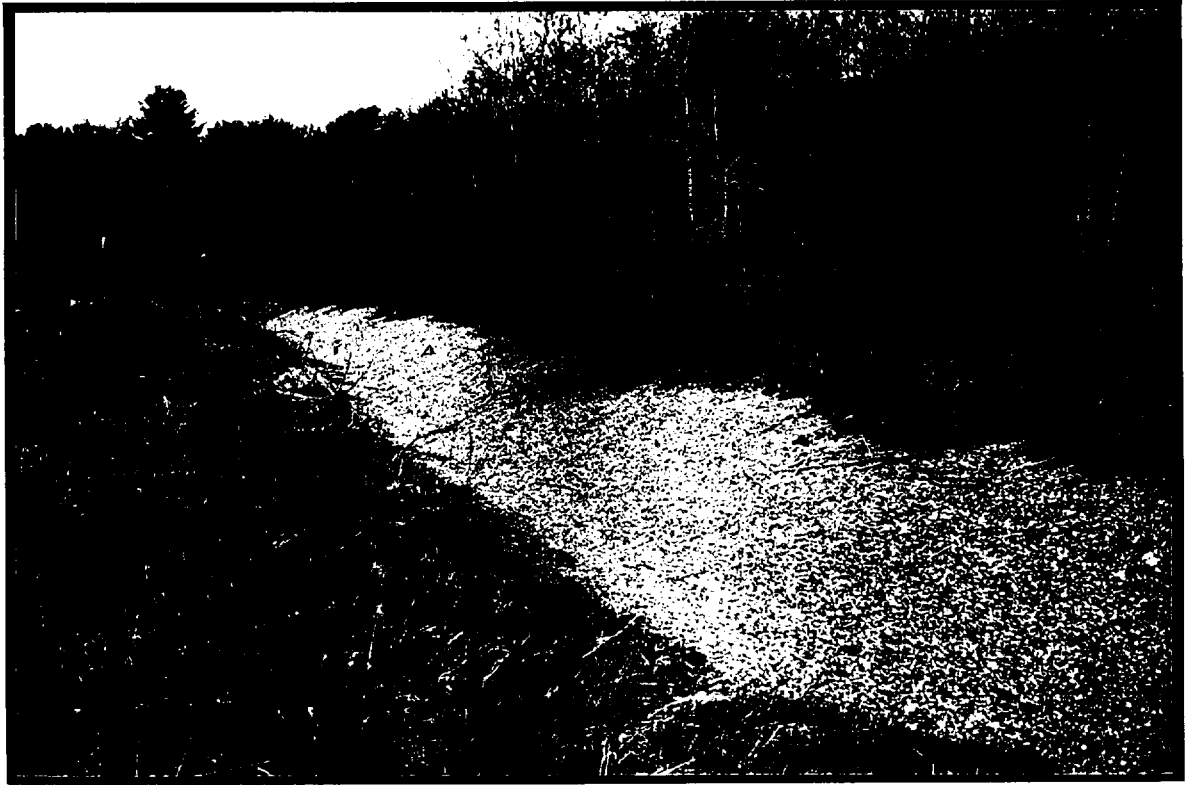
Inspection of the drainage swale revealed well maintained conditions with few exceptions. Photograph 5 shows a typical view of the drainage swale. Lined with a bed of 3/4-inch stone, the swale is approximately 8 to 10 feet wide with side slopes of about 2H:1V. There are 4 asphalt lined channels for discharge of waters collected in the drainage swale. These channels discharge into the wetlands of the Elm Brook. The drainage swale is generally free of debris and vegetative growth. In the western edge of the landfill cap, low brush was observed growing in two areas of the swale. Debris was seen in the drainage swale along the southern edge of the cap, near the softball field. If not removed and properly maintained, both could restrict the flow of water in the drainage swale.

5. Typical view of drainage swale. Photo of northern drainage swale.

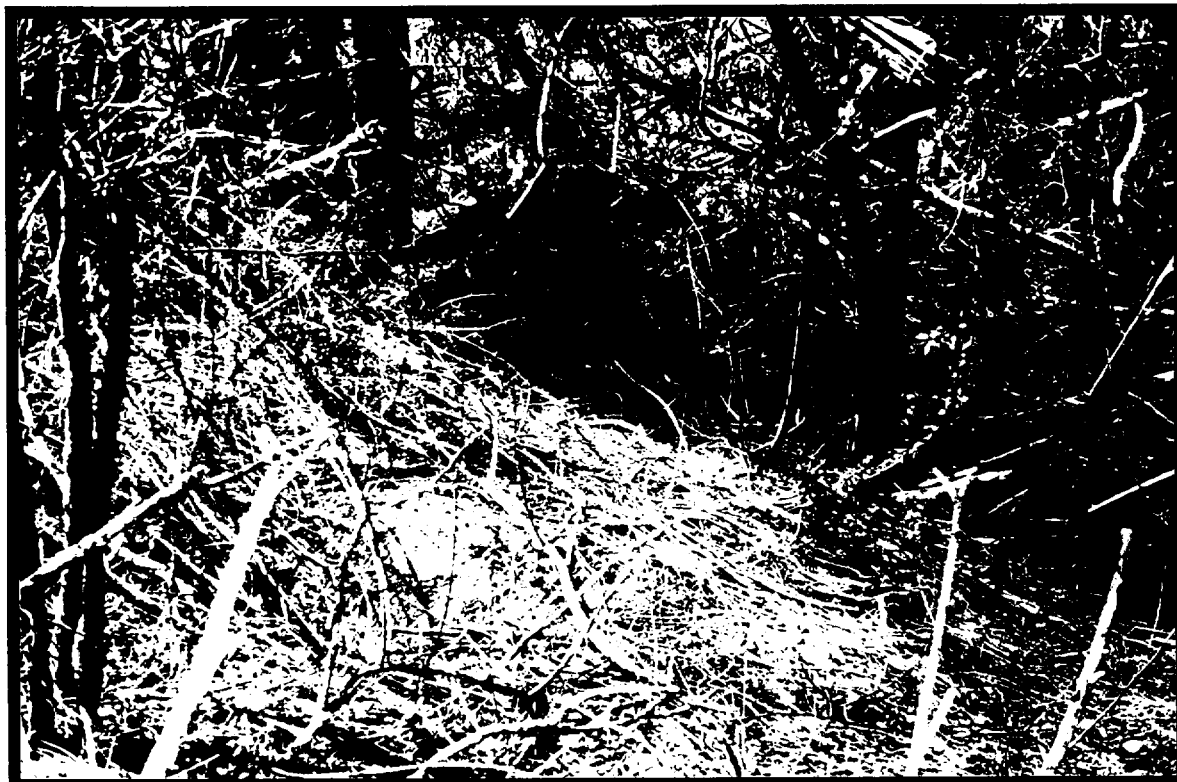
Photographs 8 through 10 show typical conditions of the side slopes of the landfill. In general, the vegetation on these slopes is not maintained. Large trees, low brush and debris are commonly found throughout the side slopes of the landfill. Side slopes along the northwestern edge of the landfill are relatively flat. Along the southern edge of the landfill, side slopes are approximately 1V:1H.

All slopes appeared to be stable with no major areas of sloughs or slides. Areas of erosion, however, were seen during the inspection. Note that full inspection of all slopes was hindered due to the heavy vegetative growth.

10. View of southern side slope showing steepness of slope and heavy vegetative growth.

With respect to the side slopes of the landfill, it is recommended that maintenance procedures follow the original design intent of the capping system, i.e. leave as is. Inspection of the side slopes should, however, continue on an annual basis. Any future areas of instability should be noted and investigated if conditions could affect the integrity of the landfill capping system.
